**Building 594 Waste Ion-Exchange Facility  
D&D Project**

**Building 594 Waste Ion-Exchange Facility D&D**

**Building 200/205 Pneumatic Transfer Tube  
D&D Project**

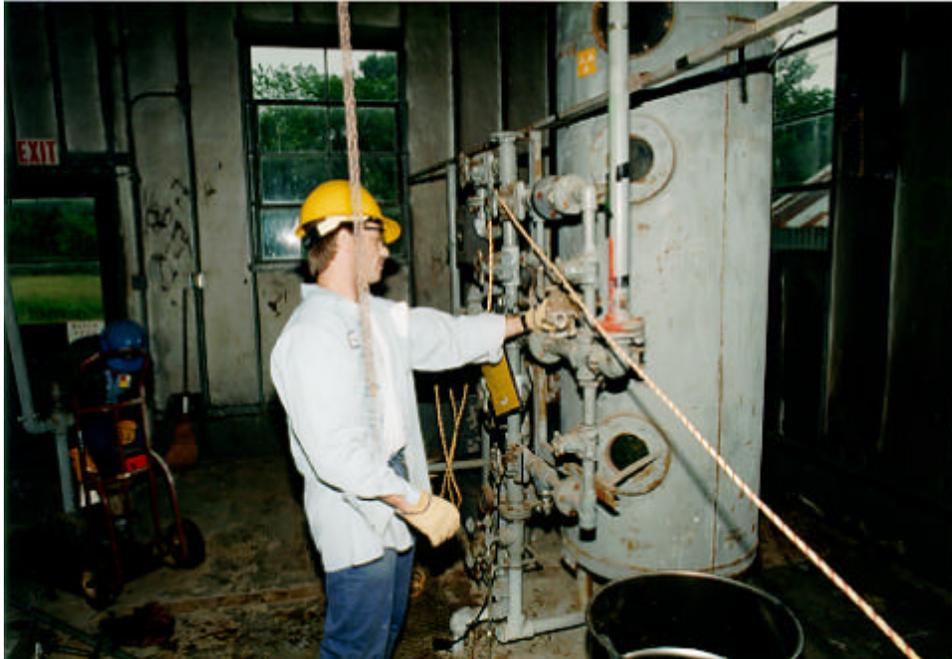
An ANL-E Waste Management Operations D&D worker removed valves from the waste ion-exchange system prior to demolition (ANL Neg. No. 24344K, Frame 8).

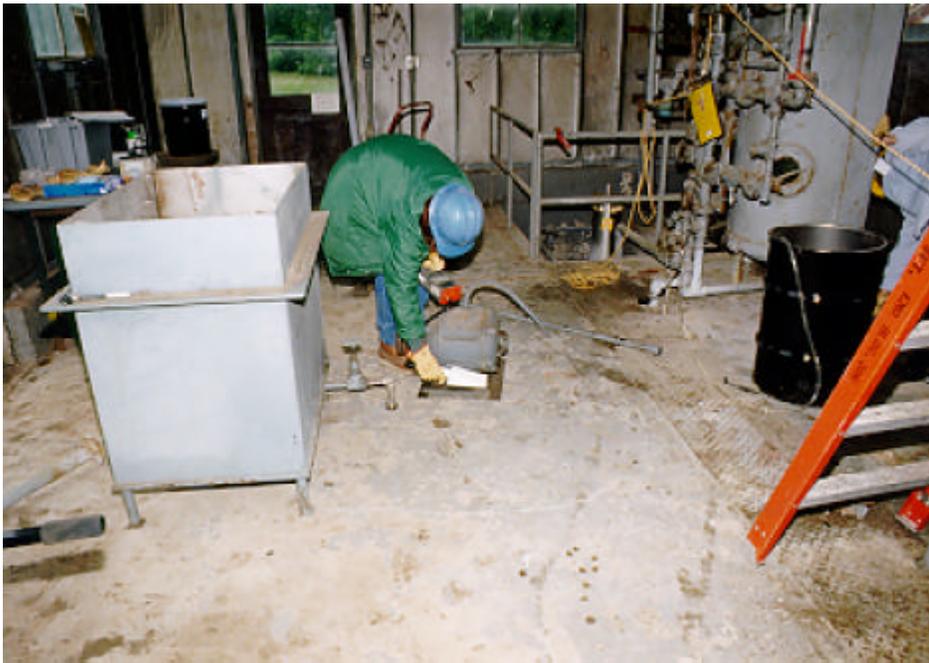
Prior to dismantlement of the ion exchange system, miscellaneous components were surveyed by ANL Health Physics technicians and released to the clean scrap pile for recycling (ANL Neg. No. 24344K, Frame 7).

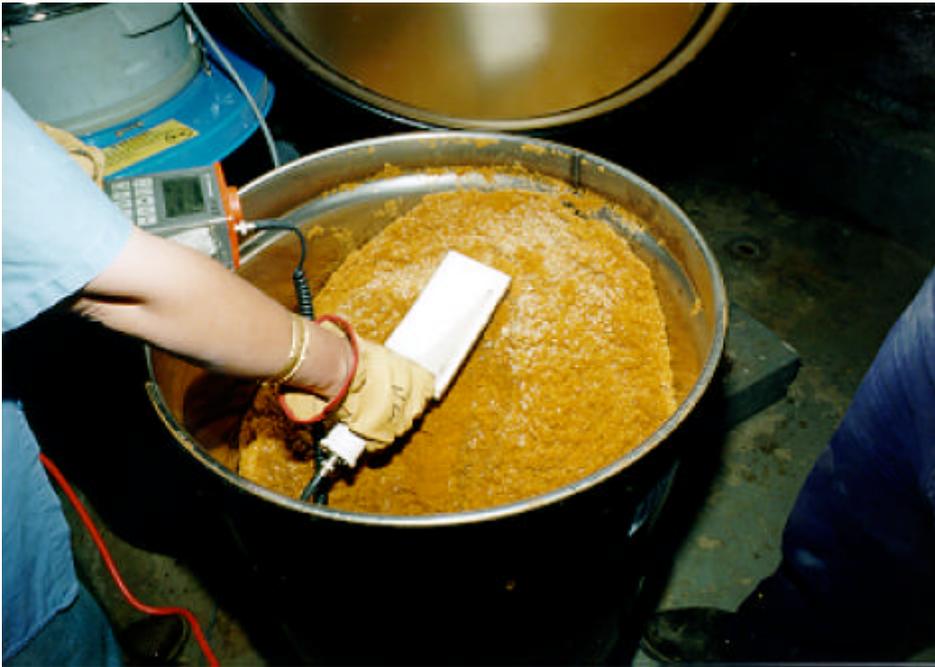
After all piping and valves were removed, the tops of the ion-exchange tanks were opened to gain access to the resin that had been used as filter material. Before removal, ANL Health Physics technicians surveyed the resin prior to disposal (ANL Neg. No. 24344K, Frame 16).

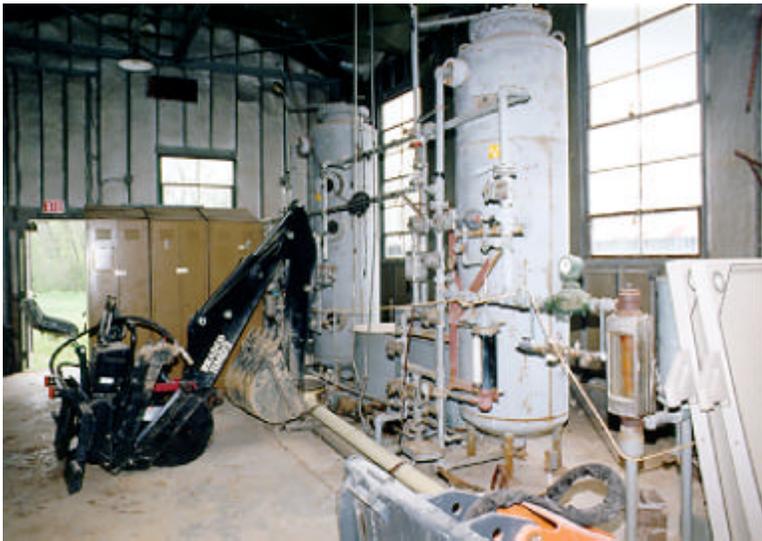
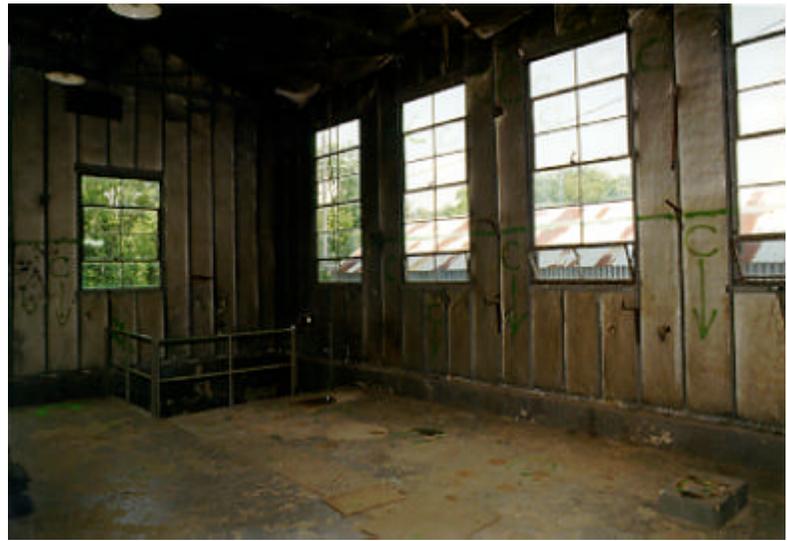
Bldg. 594 was cleared of all equipment and components after D&D and prior to demolition, as shown in these before and after photos. This view looking north (ANL Neg. Nos. 24193K, Frame 5A, and 24571K, Frame 2A).

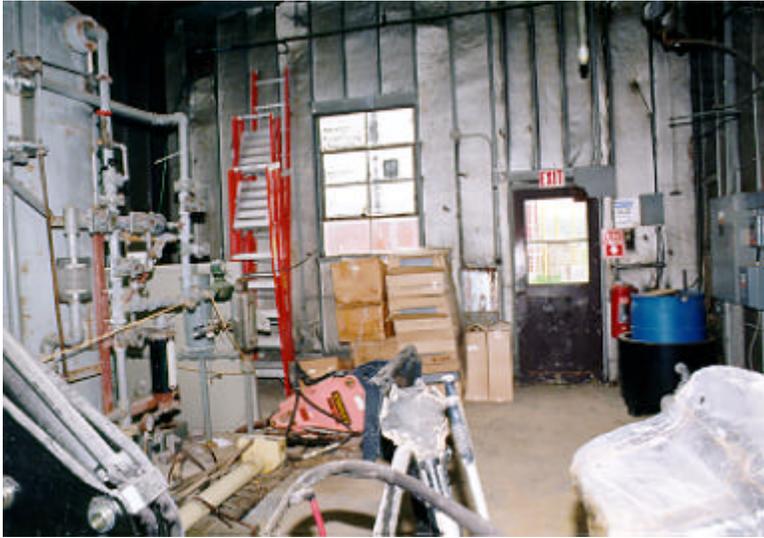
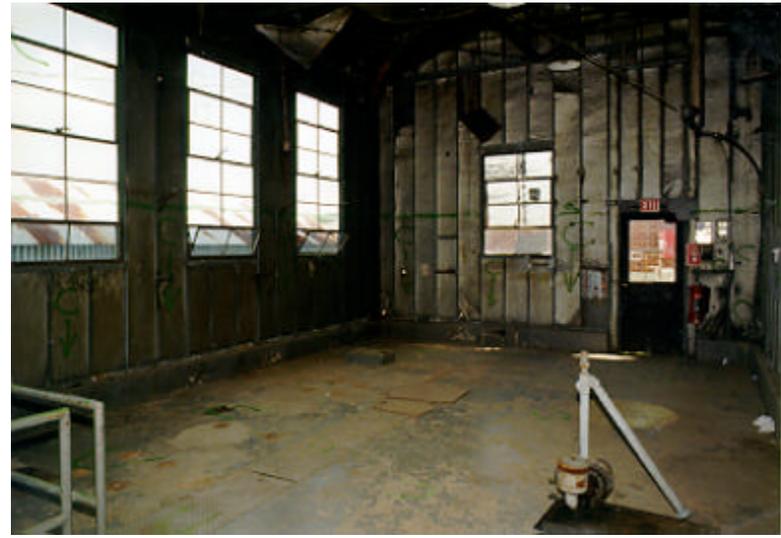
These photos are of the interior of Bldg. 594, looking south, before and after D&D (ANL Neg. Nos. 24193K, Frame 10A, and 24571K, Frame 3A).

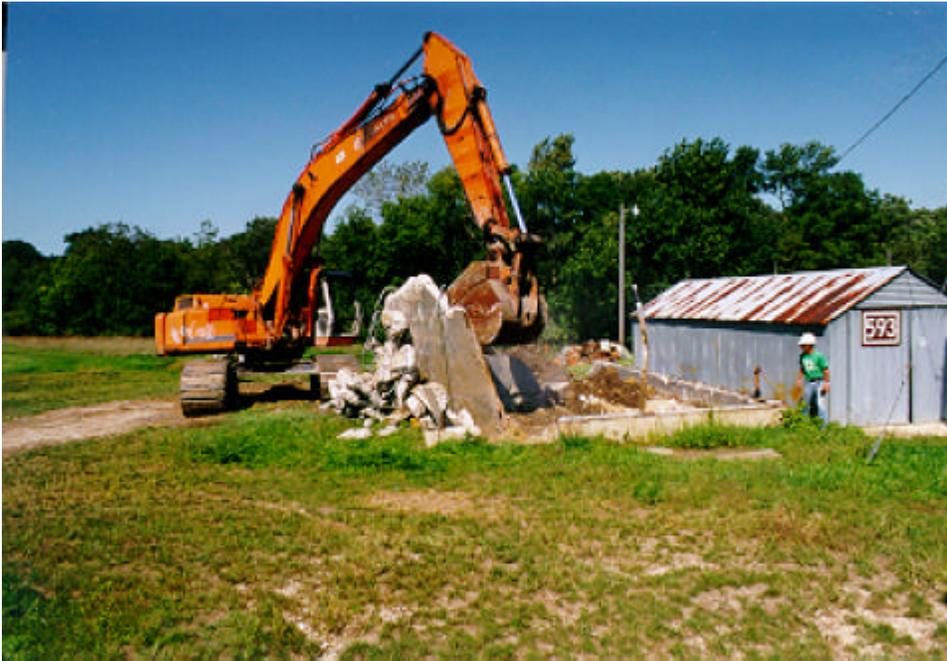
Action Wrecking removed the concrete floor and foundation. After the material was size-reduced, it was removed from the site (ANL Neg. No. 24693K, Frame 1).

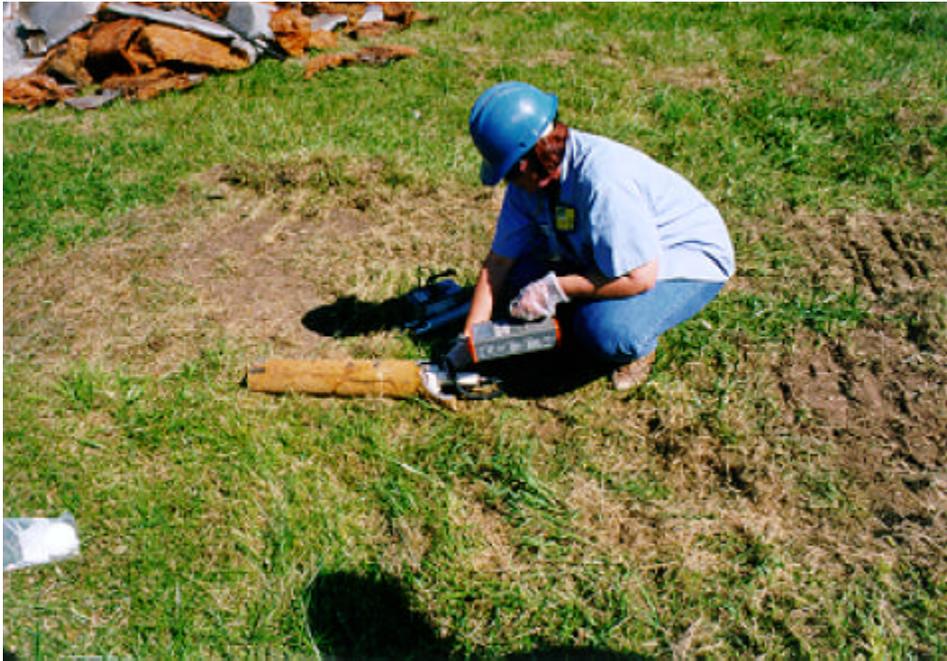
All underground piping associated with Bldg. 594 and the soil surrounding the piping were surveyed by ANL Health Physics technicians (ANL Neg. No. 24693K, Frame 7).

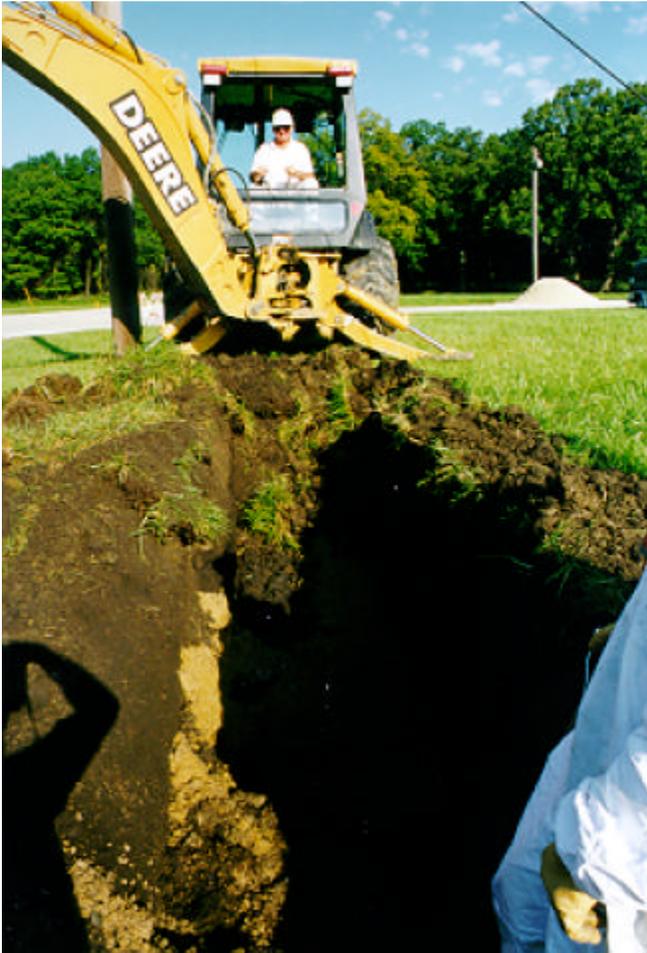
Northwest Contractors (Elgin IL) was hired by ANL Plant Facilities and Services to perform the excavation and the restoration work. Once the trench was dug, it was surveyed by ANL Health Physics technicians for loose contamination. The wooden plank covering the tube was removed, uncovering the tube from its sand bedding. The tube was examined for holes or punctures and surveyed (ANL Neg. No. 24692K, Frame 22).

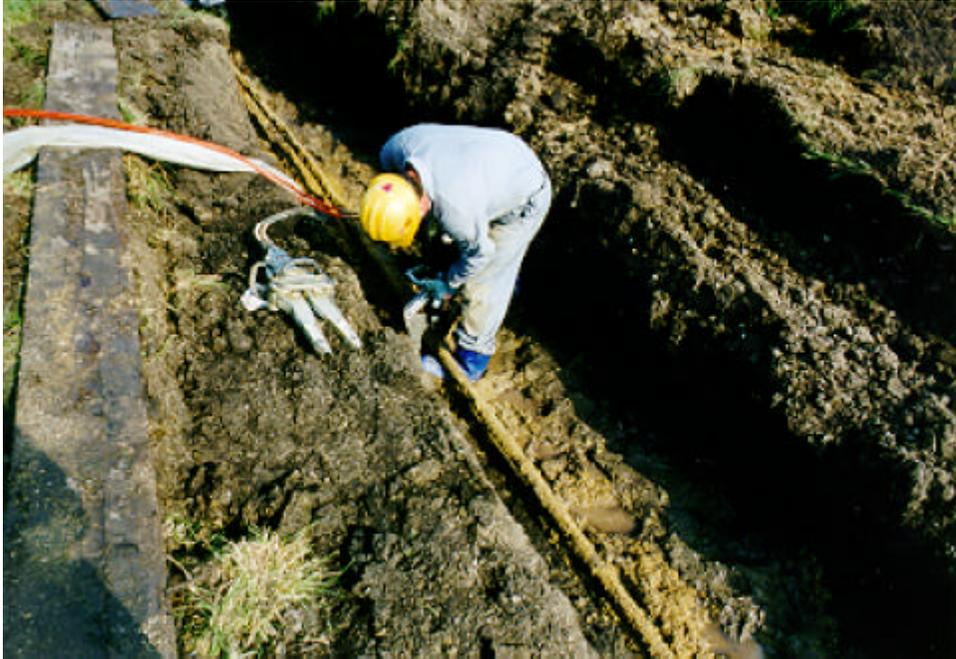
Argonne's Waste Management Operations (WMO) was responsible for the removal and size reduction of the tube, and for its packaging and disposal as low-level waste. WMO technicians first flattened the tube at various intervals using a hydraulic crimper. The tube was then cut in the middle of each crimped area using a hydraulic cutter. Tube ends were taped over and further size reduced as needed for disposal (ANL Neg. No. 24692K, Frame 24).
