**Building 594 Waste Ion-Exchange Facility  
D&D Project**

**Building 594 Waste Ion-Exchange Facility D&D**

**Building 200/205 Pneumatic Transfer Tube  
D&D Project**

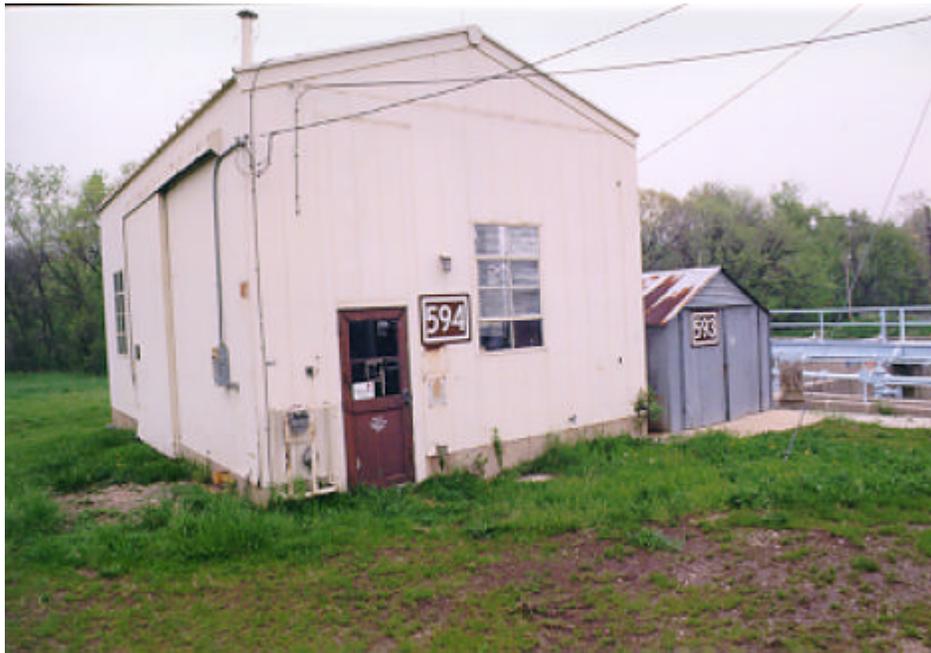
Building 594 (a.k.a. 579) was a pre-engineered metal building with a concrete foundation and floor (ANL Neg. No. 24191K, Frame 12).

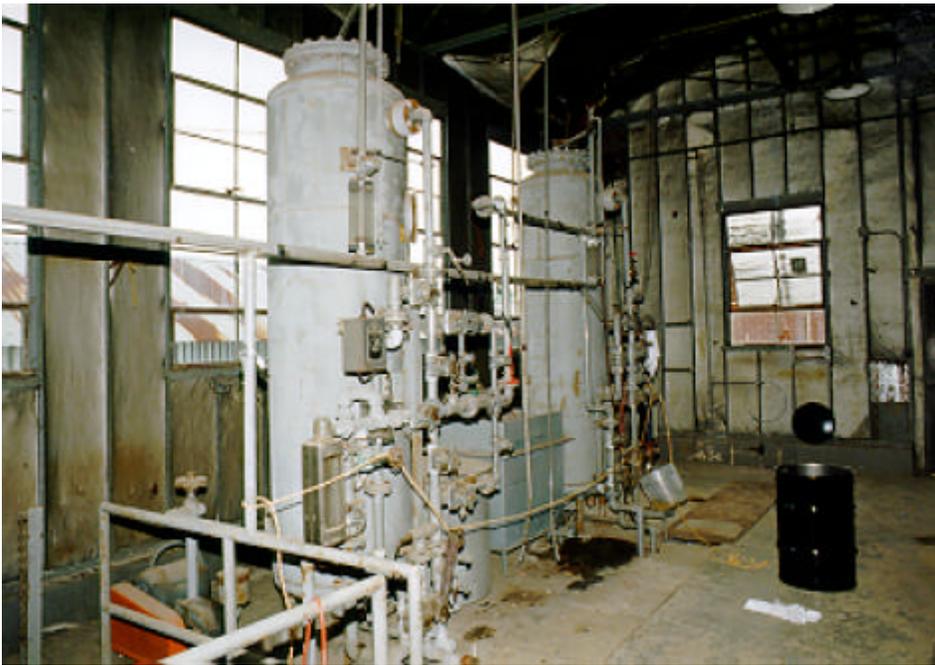
The waste ion-exchange equipment located on the east side of Building 594 consisted of two resin tanks, a cation exchange vessel, and a mixed bed exchange vessel (ANL Neg. No. 24344K, Frame 5).

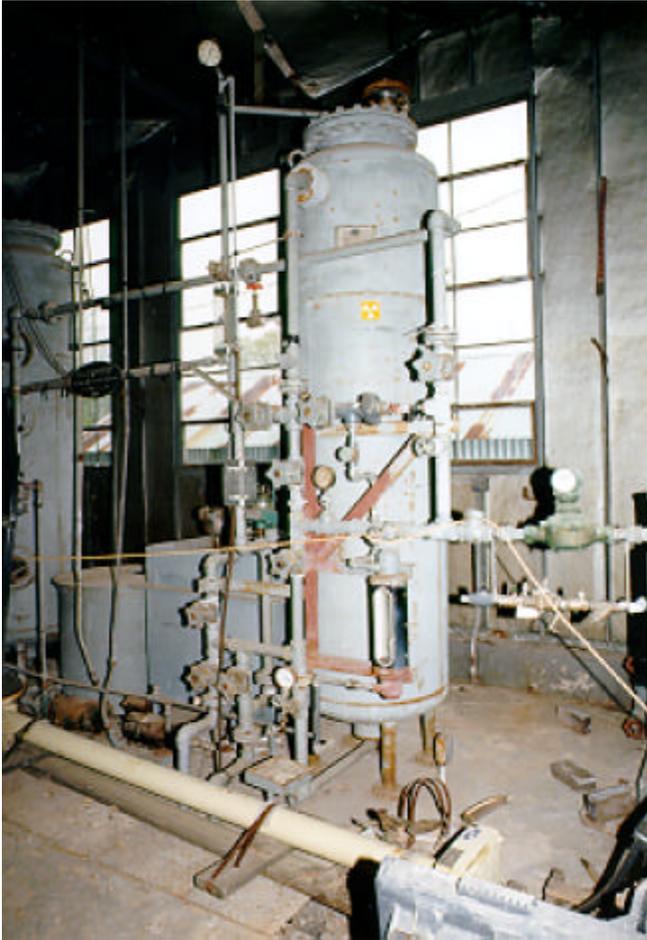
Connected to the cation exchange vessel were a caustic regenerant tank and an acid regenerant tank along with miscellaneous piping, valves, gauges, and pumps (ANL Neg. No. 24191K, Frame 26).

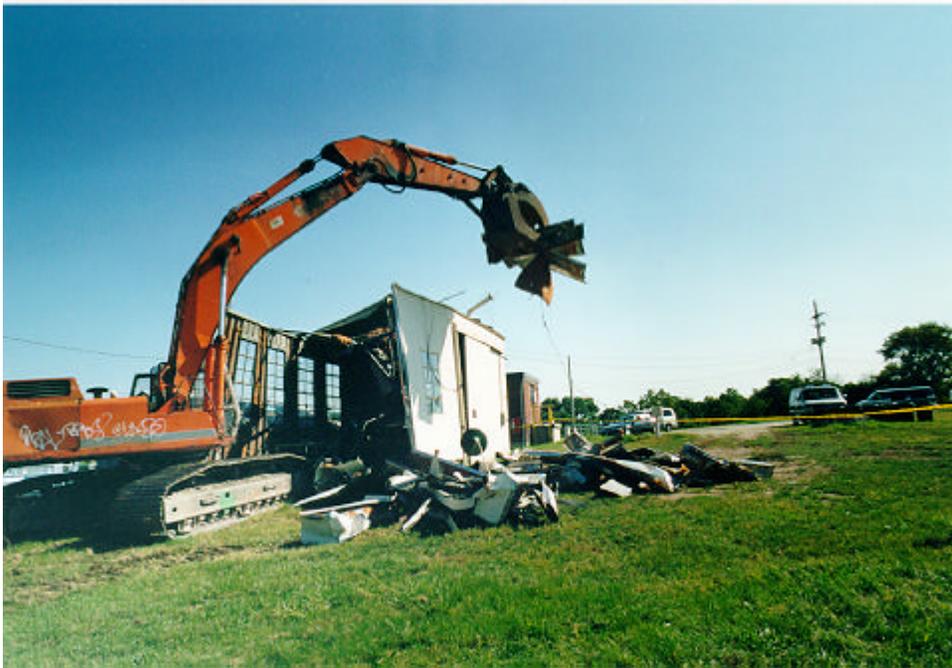
In August, a contract was awarded to Action Wrecking Company (Darien IL) to demolish Bldg. 594. Demolition took place in September (ANL Neg. No. 24692K, Frame 9).

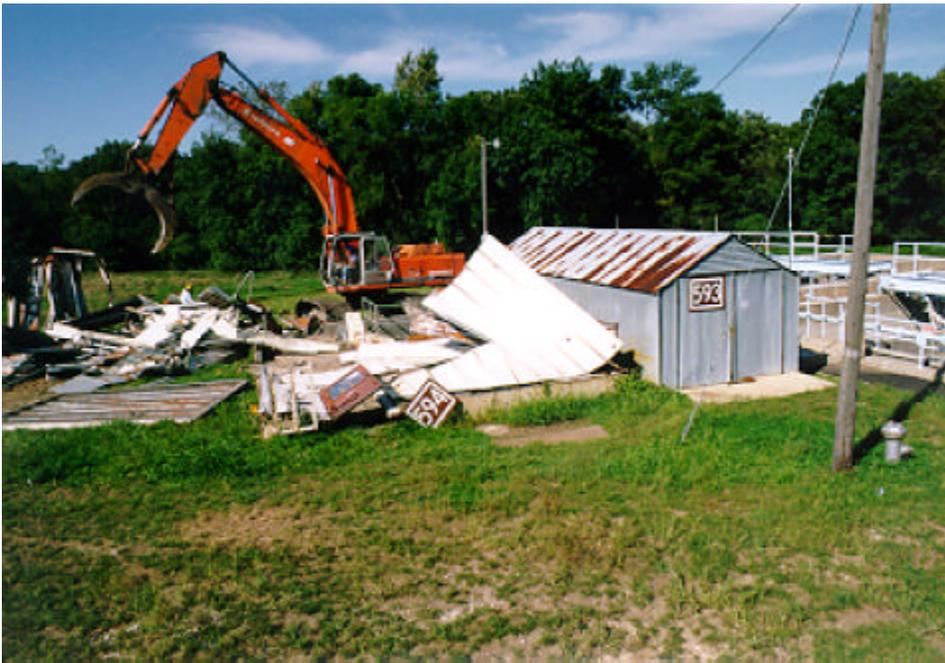
Once demolition was completed, materials were segregated for recycling (ANL Neg. No. 24692K, Frame 17).

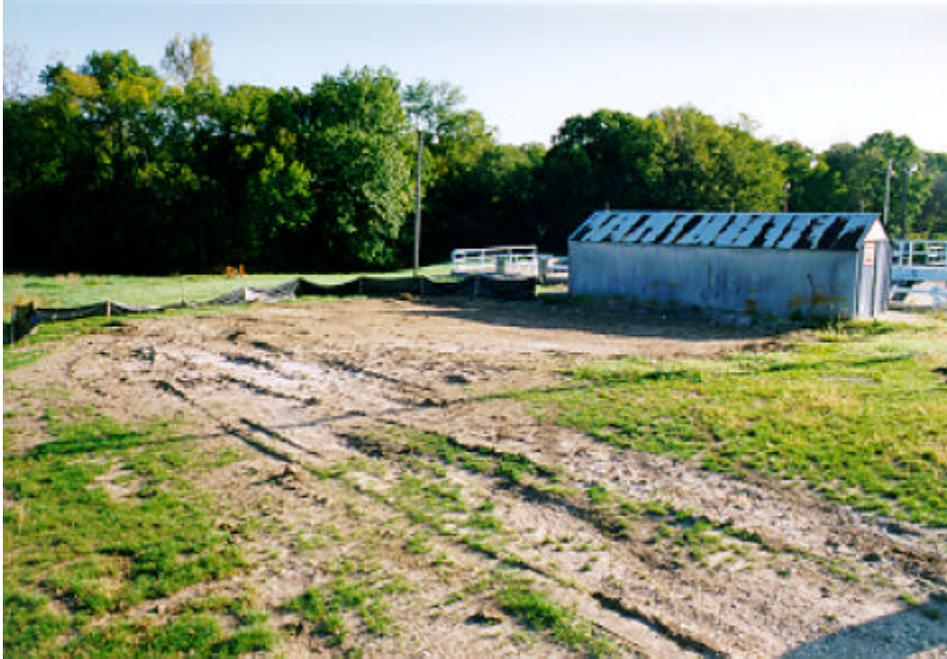
In September, after all demolition activities were completed, the area was backfilled with dirt and made ready for grading and seeding (ANL Neg. No. 24693K, Frame 10).

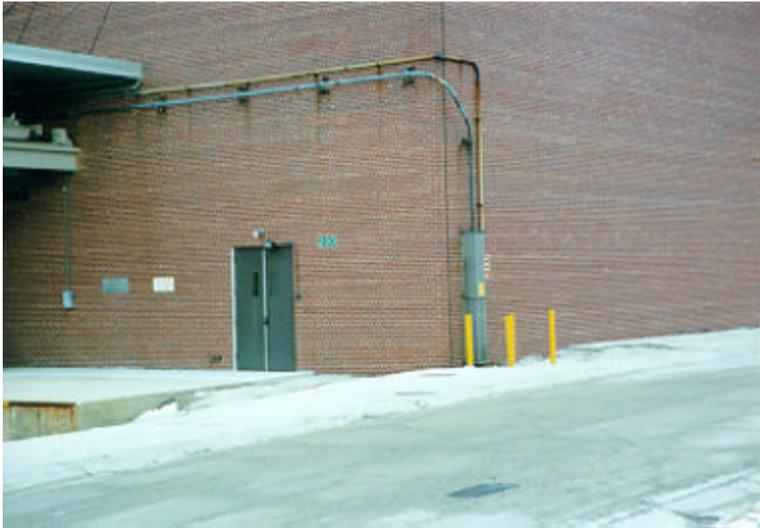
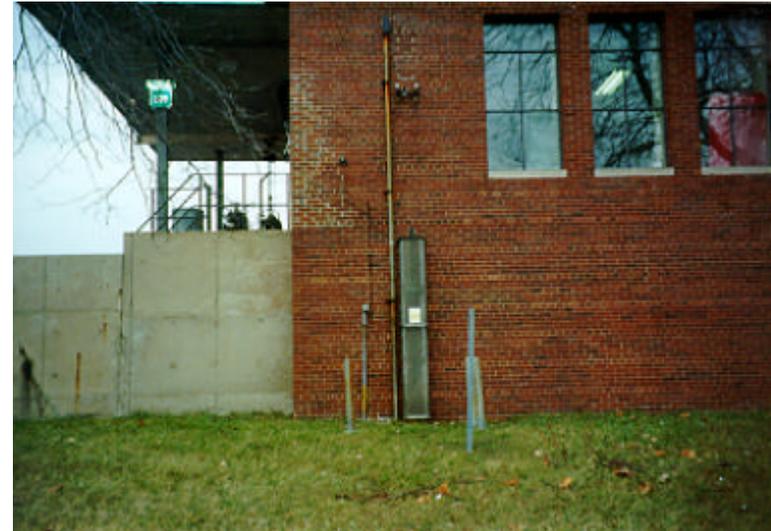
The Bldg. 200/205 pneumatic transfer tube was constructed in the late 1960s to transfer irradiated fuel specimens and other samples between Hot Cell M-4 in Bldg. 200 and a glove box in Room F-131, Bldg. 205. The tube was in operation until the mid-1970s. Project scope encompassed only the removal of the tube between the two buildings and not the facilities within the buildings (ANL Neg. Nos. 23887K, Frames 25 and 6).

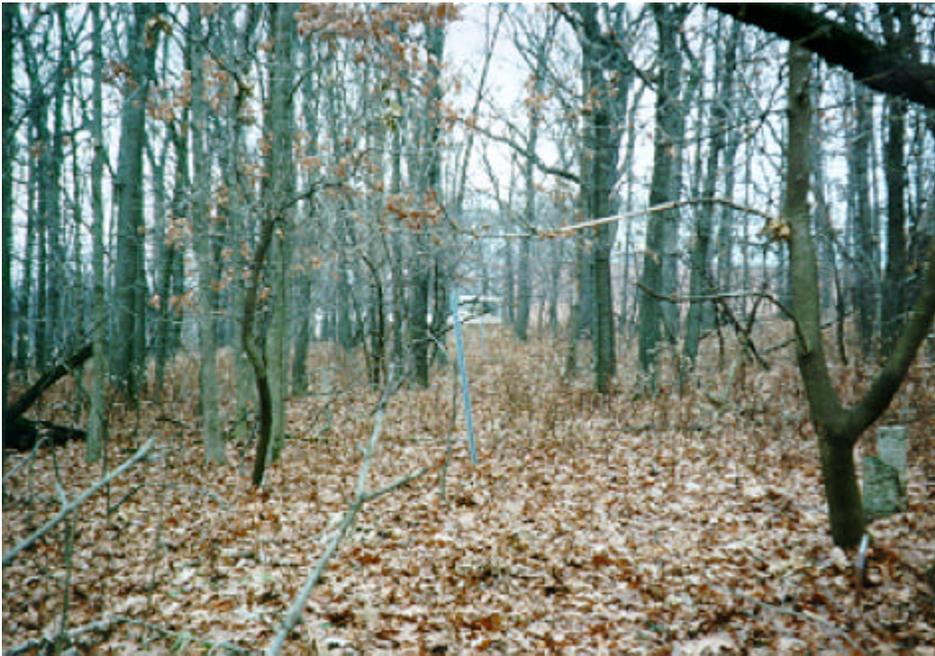
The pneumatic transfer tube system ran 4 feet underground for approximately 1,850 linear feet. It was routed through the woods south of Bldg. 200 until it approached Outer Circle Road. There it turned southeast, and followed the road 600 feet before it turned east toward Bldg. 205 (ANL Neg. No. 23887K, Frame 20).
